**NASA  
Reference  
Publication  
1291**

# Fractography Handbook of Spaceflight Metals

Rebecca J. Derro

Rebecca J. Derro  
*Goddard Space Flight Center*  
*Greenbelt, Maryland*

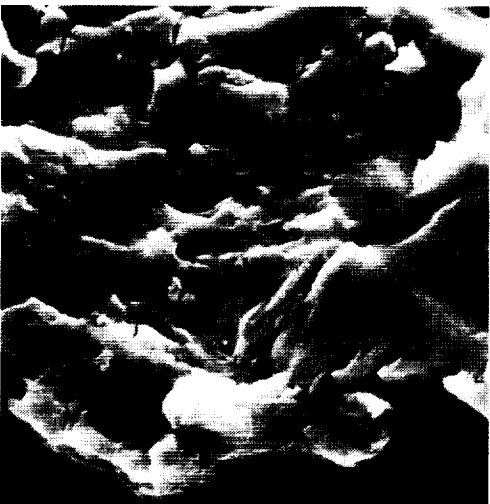
Fig. 3-42 2500X  
Region 3.

Figures 3-40 to 3-44 Region 3: Striations are more evident as a smaller load ratio is applied.

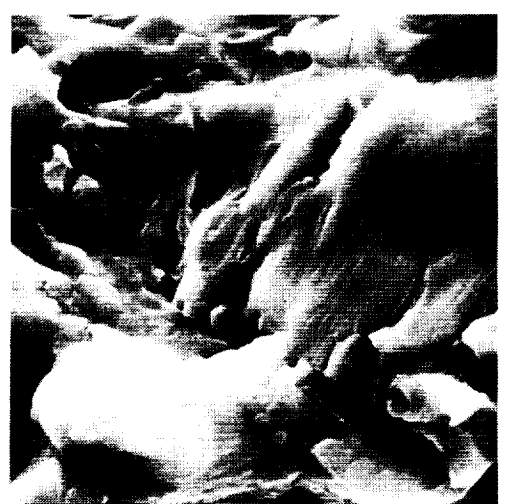
Fig. 3-43 5000X  
Region 3

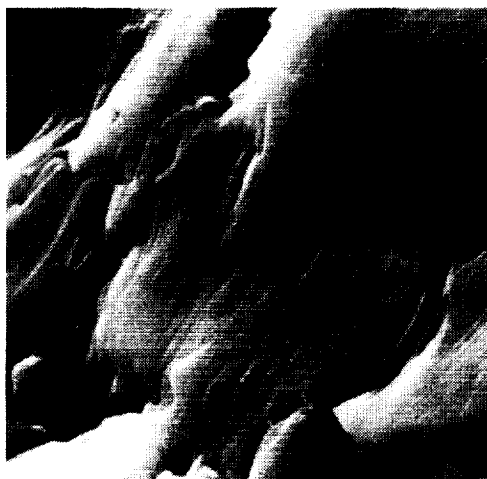
Fig. 3-44 10000X  
Region 3

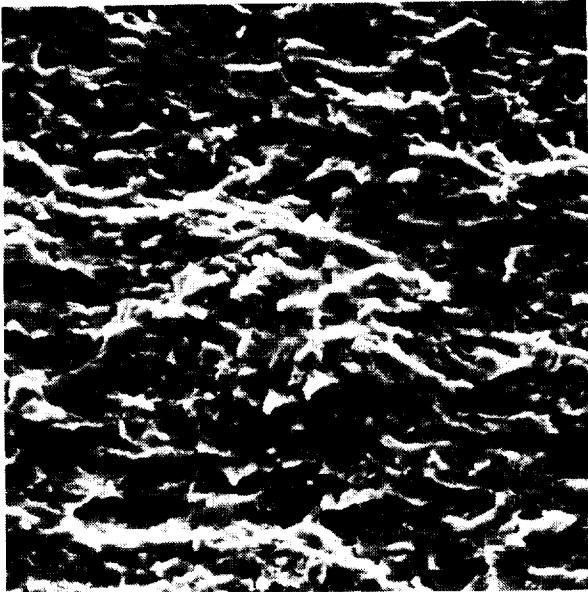
Fig. 3-45  
Region 4. Fatigue striations. 640X

Figures 3-45 to 3-48 Region 4: The striations are more pronounced as we apply an even smaller load ratio.

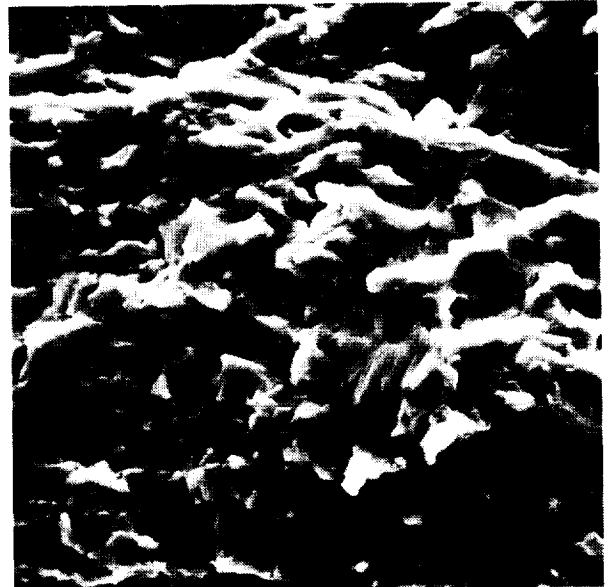
Fig. 3-46  
Region 4. 1250X

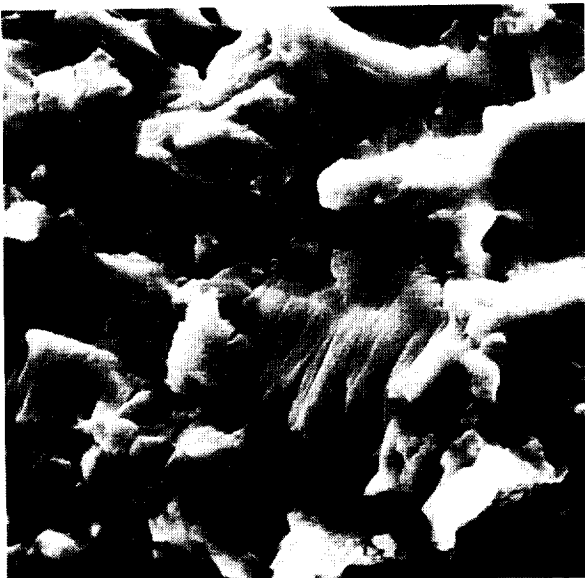
Fig. 3-47  
Region 4. 2500X

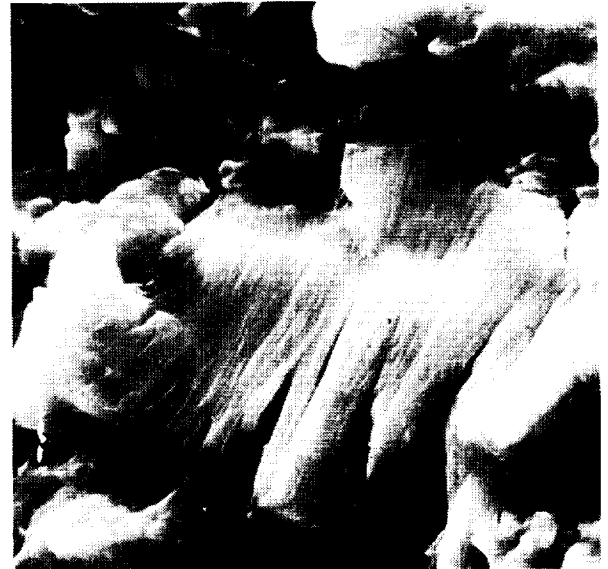
Fig. 3-48  
Region 4. 5000X

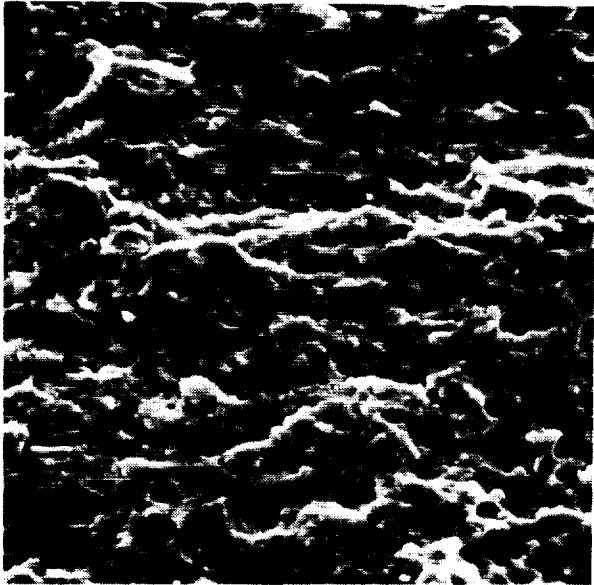
Fig. 3-49  
Region 5. Fatigue striations. 640X

Figures 3-49 to 3-52 Region 5: The fractographs resemble those for area 4.

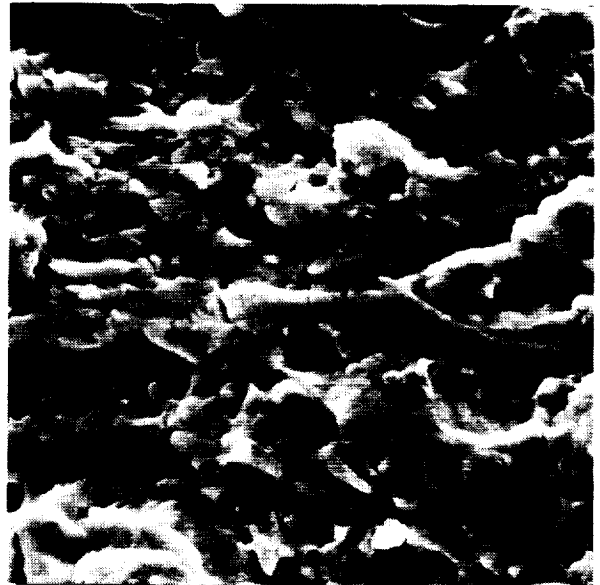
Fig. 3-50  
Region 5. 1250X

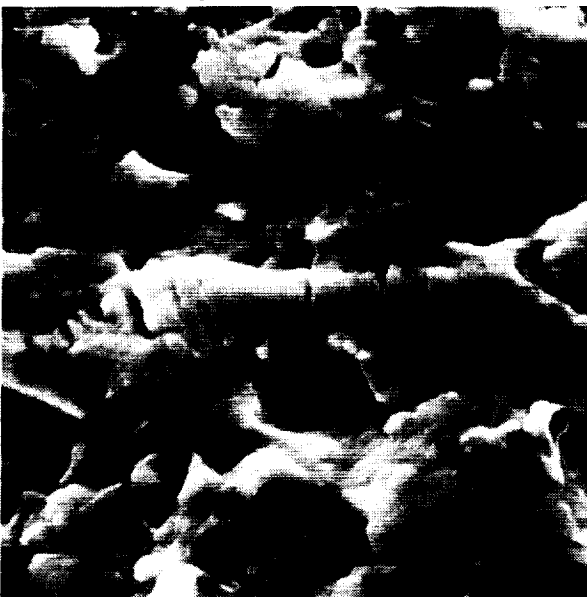
Fig. 3-51  
Region 5. 2500X

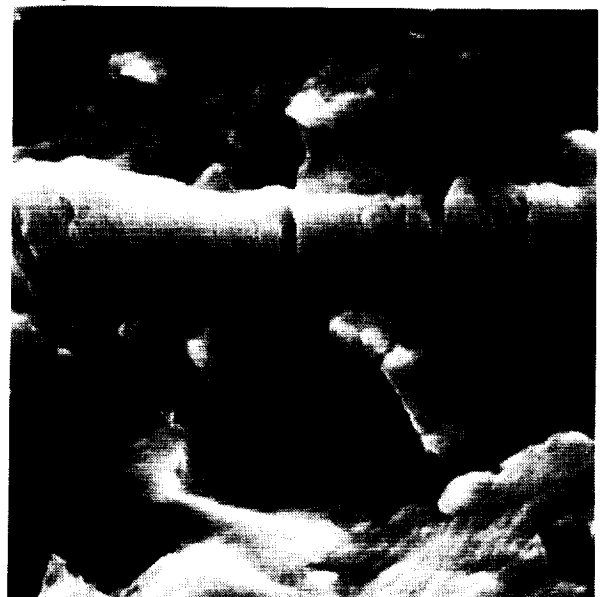
Fig. 3-52  
Region 5. 5000X

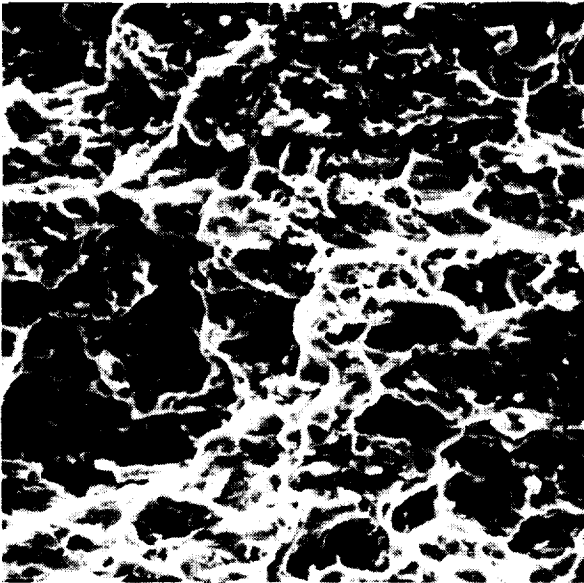
Fig. 3-53  
Region 6. Fatigue striations. 640X

Figures 3-53 to 3-56 Region 6: In this region the  $K_{max}$  value is increased but the R value is the same as Regions 2 thru 5. Note that the striation spacings are about the same size as those in Region 3.

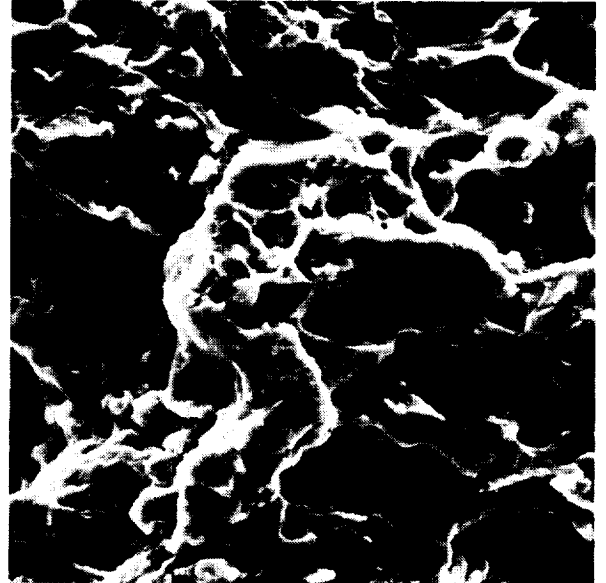
Fig. 3-54  
Region 6. 1250X

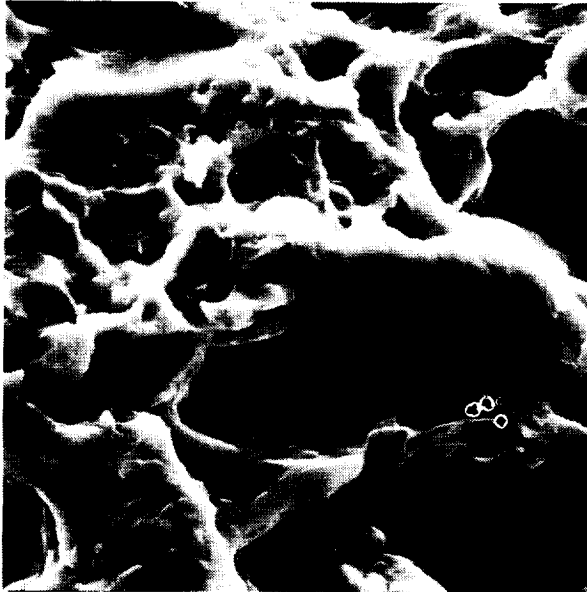
Fig. 3-55  
Region 6. 2500X

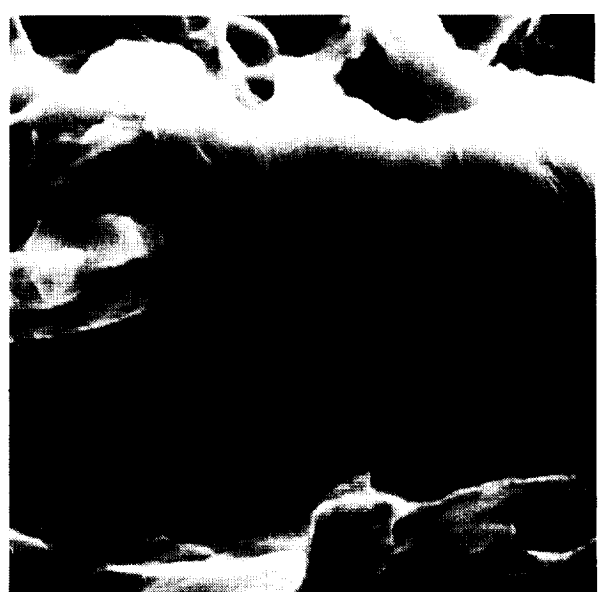
Fig. 3-56  
Region 6. 5000X

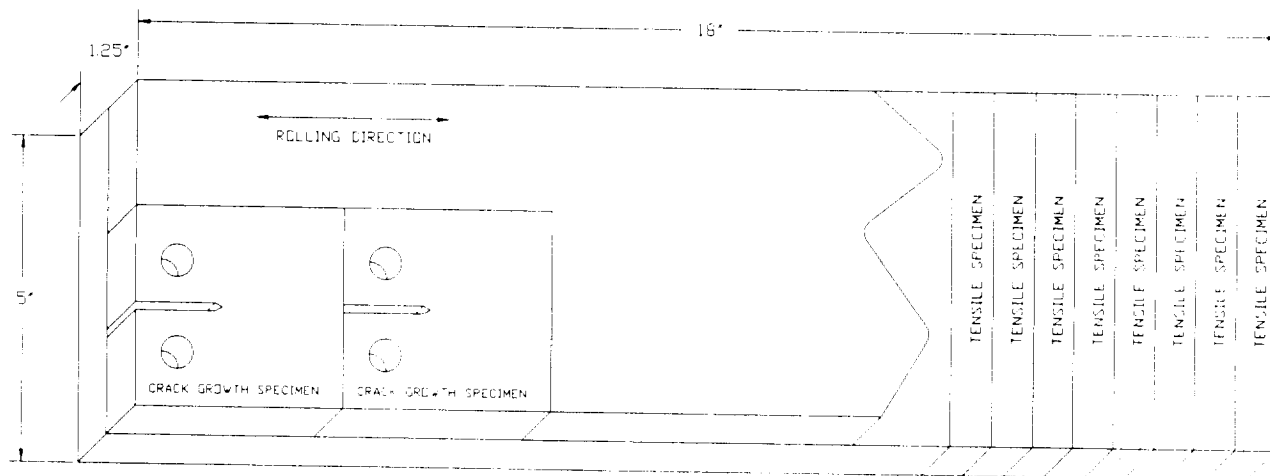
**Figure 4-a. Pattern used to cut test specimens.**

**Dimensions:** 1.25" Tk X 5.00" W X 18.0" L plate. Test specimens were cut from the plate according to the diagram in Figure 4-a.

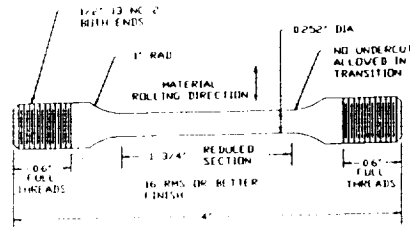
Figure 4-b. Smooth tensile overload specimen, 4" long, 0.252" diameter.

The dimensions for the smooth tensile overload specimens are shown in Figure 4-b, and the dimensions for the notched tensile overload specimens are shown in Figure 4-c. The compact tension specimen dimensions are shown in Figure 4-d.

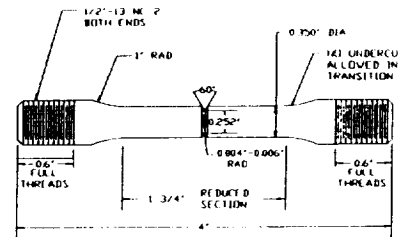
Figure 4-c. Notched tensile overload specimen, 4" long, 0.004-0.006" root radius, 0.252" notch diameter.

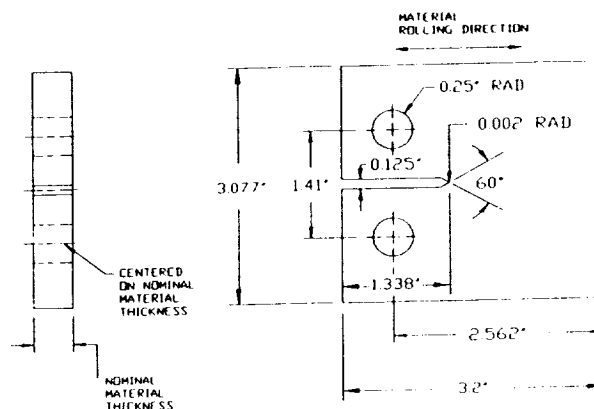
Figure 4-d. Compact Tension Specimen

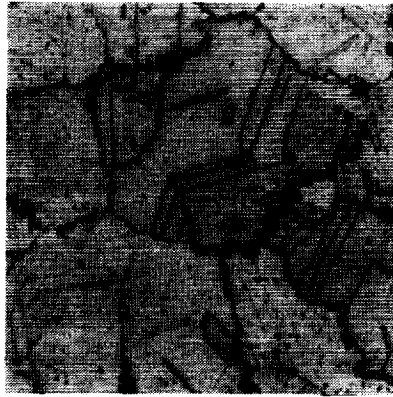
Specimen was etched with Copper Etch (4 ml Saturated NaCl, 8 ml H<sub>2</sub>SO<sub>4</sub>, 2 gms Potassium Dichromate, 100 ml H<sub>2</sub>O). The microstructure contains a dark colored gamma phase in the grain boundaries, with uniformly dispersed dark cobalt-beryllide and light primary beta particles also present. Note the twin formation due to working of the metal. The low magnification photograph in Figure 4-3 shows large bands distributed in the microstructure. These bands are also visible in the fracture surfaces.

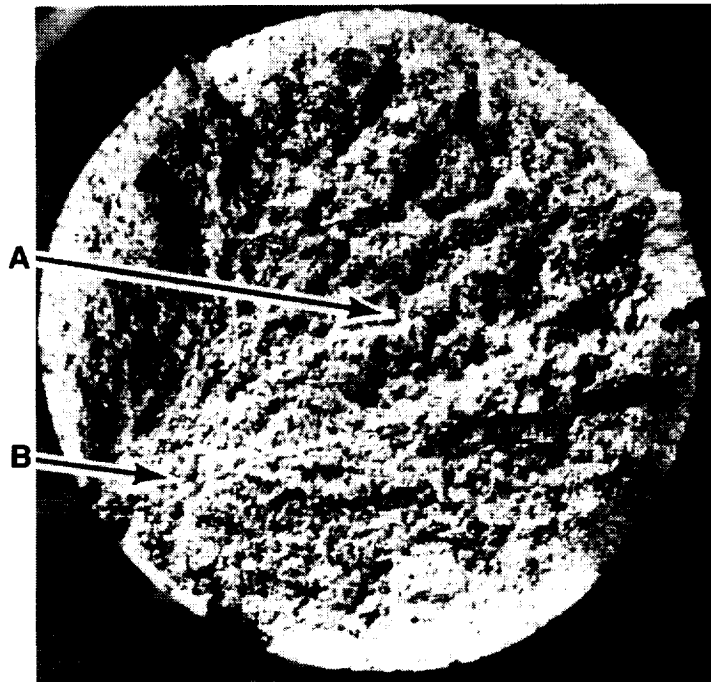
Fig. 4-4

The fracture is shown in Figure 4-4. The overall appearance of this fracture is smooth in the center with radial lines originating from the fracture origin. Several shear lips are located circumferentially.

Optical photomicrograph of fracture surface.

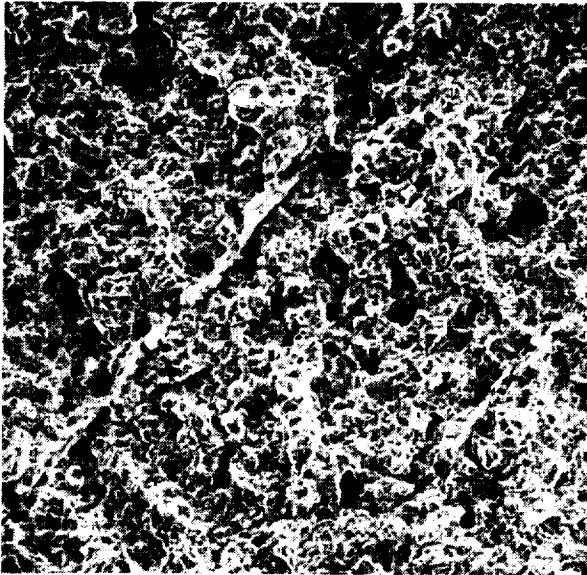
Figures 4-5 to 4-11 Area A: These fractographs are representative of the fracture morphology in the center of the sample. There is transgranular fracture, secondary cracking, and cracking along the long bands that are seen in the microstructure (Fig 4-5 to 4-7). Dimple rupture is evident at both low and high magnification. Dimples are seen on the secondary crack walls and on facet surfaces. The facets are indicated with arrowheads in Figures 4-9, 4-10 and 4-11.

Fig. 4-5  
Region A. Central area of fracture. 40X

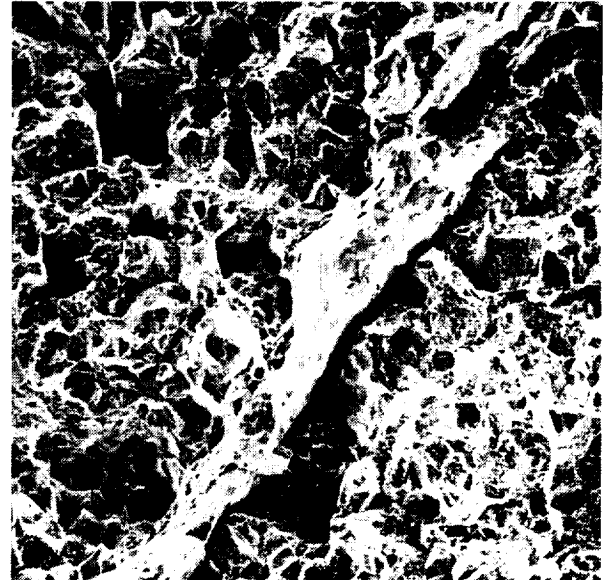
Fig. 4-6  
Region A. Secondary cracking. 160X

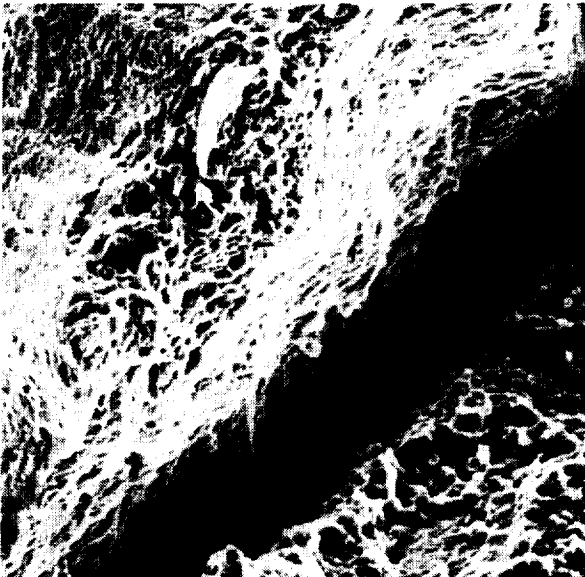
Fig. 4-7  
Region A. Enlarged view of Fig. 4-6. 1250X

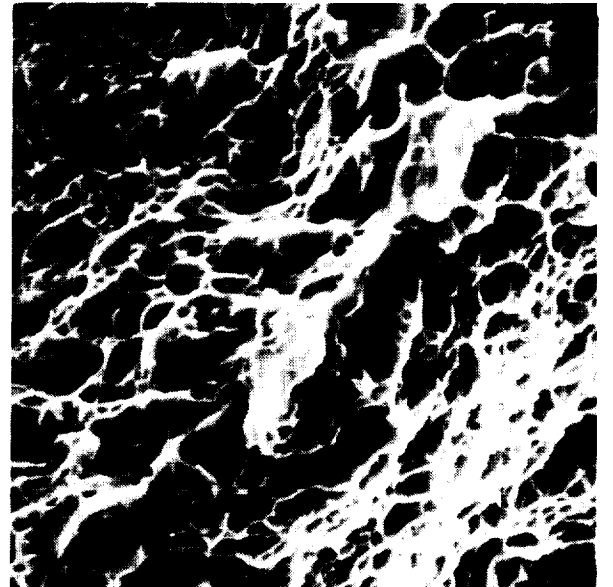
Fig. 4-8  
Region A. Microdimples on the crack surface. 5000X

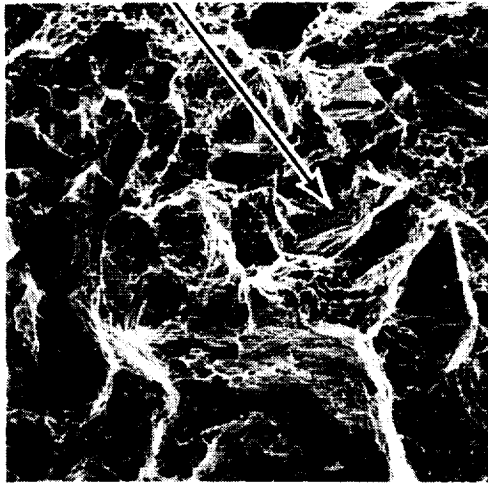
Fig. 4-9 640X  
Region A. Another area in the central  
region of fracture.

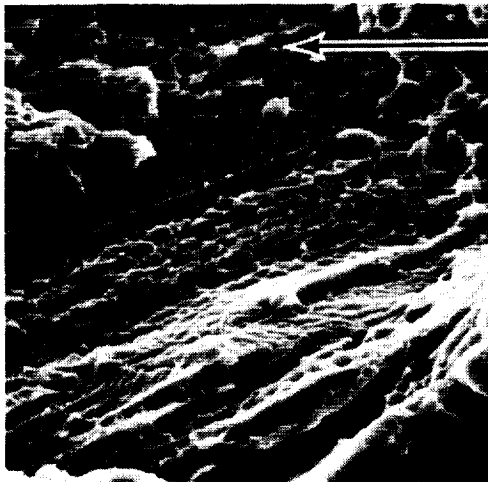
Fig. 4-10 5000X  
Region A. Microdimples on a grain facet.

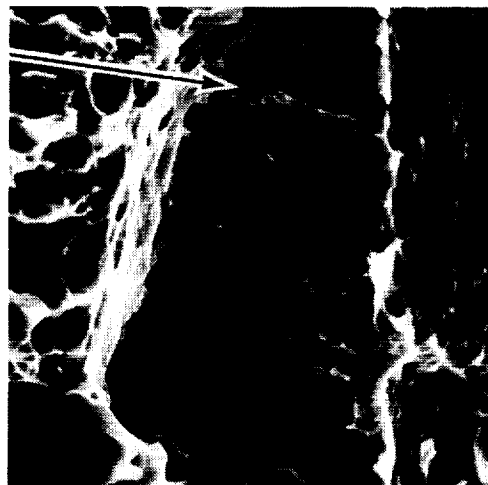
Fig. 4-11 5000X  
Region A. Microdimples on a grain facet.

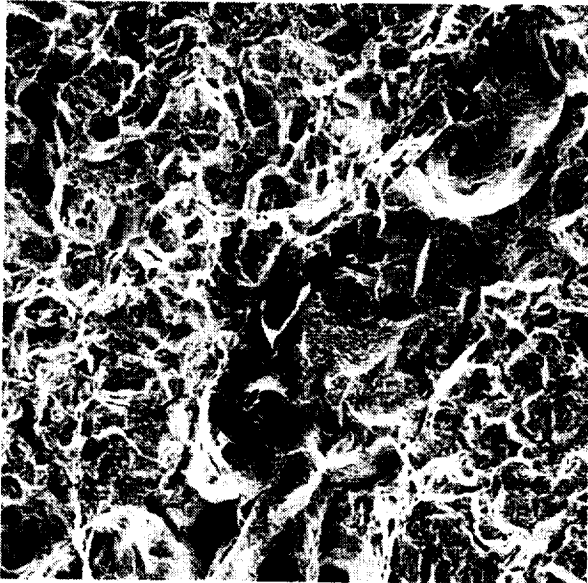
Fig. 4-12  
Region B. Secondary crack. 160X

Figures 4-12 to 4-15 Area B: Long cracks and separations on the fracture surface occur at long bands that are seen in the microstructure.

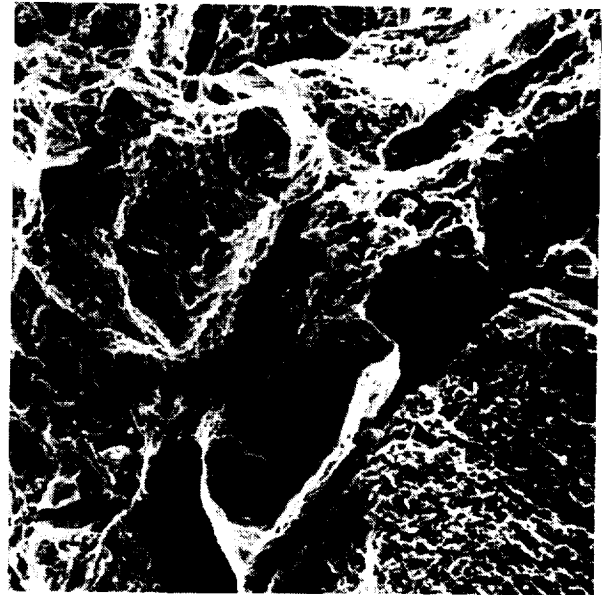
Fig. 4-13  
Region B. Enlarged view of Fig. 4-12. 640X

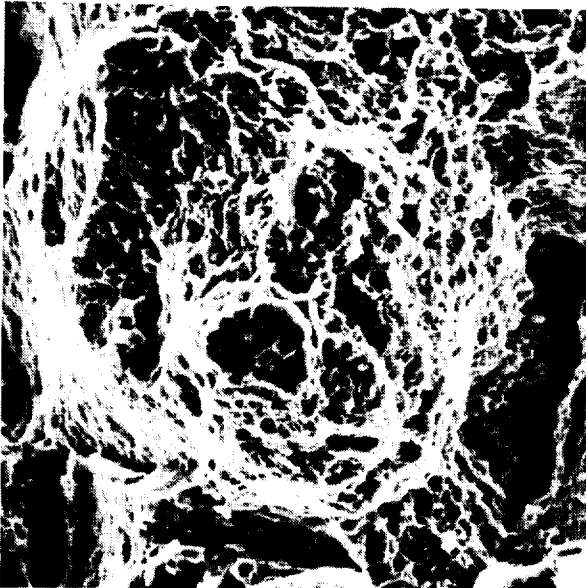
Fig. 4-14  
Region B. Enlarged view of 4-13. 1250X

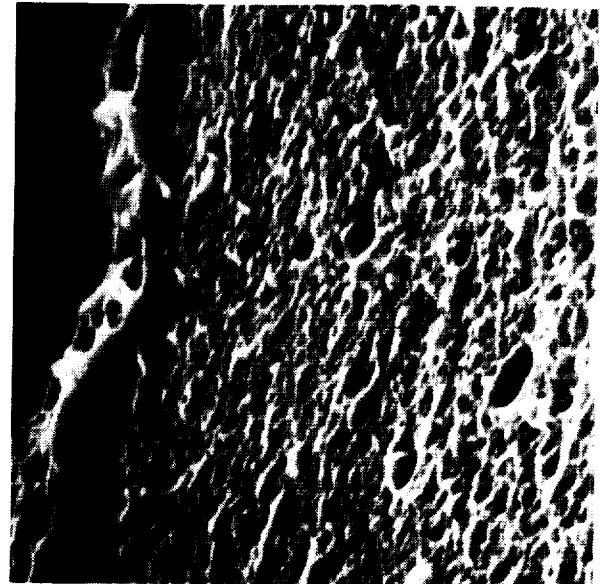
Fig. 4-15  
Region B. Microdimples on right center  
grain surface in Fig. 4-14. 5000X

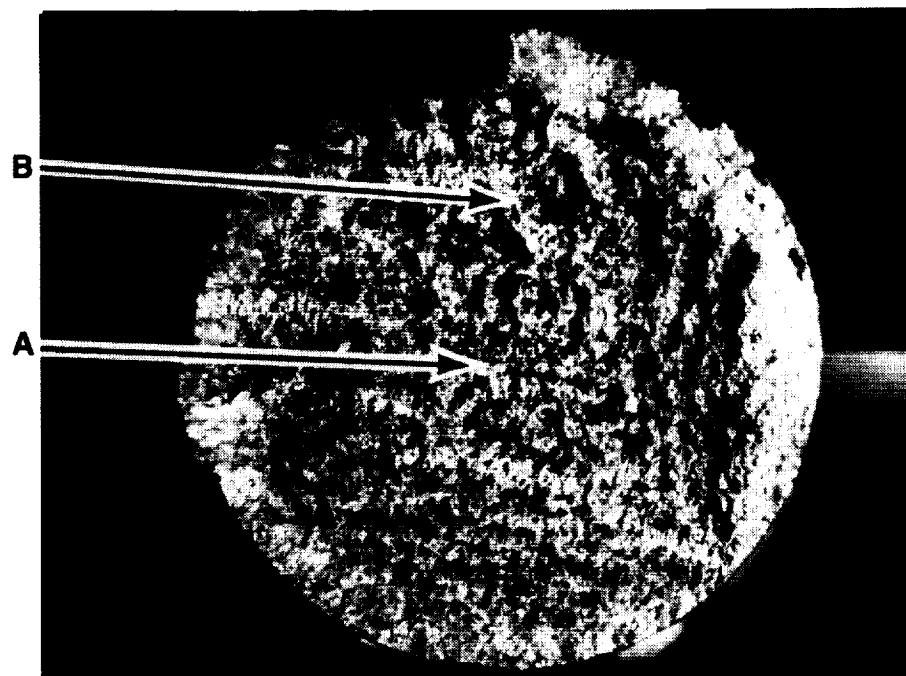
Fig. 4-16

This fracture is shown in Figure 4-16. The surface appears coarser than that of the room temperature sample. The radial lines are also more defined.

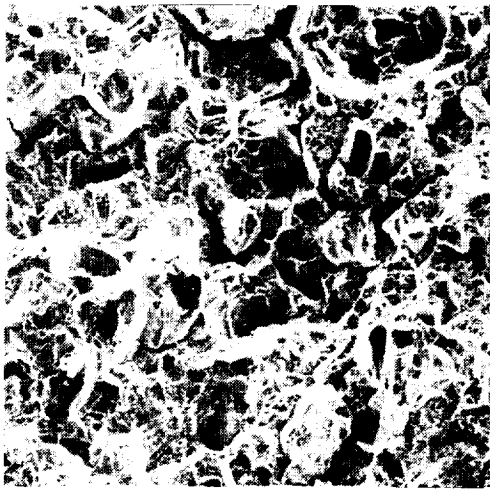
Fig. 4-17 160X  
Region A. Central zone of fracture.  
Intergranular cracking.

Figures 4-17 to 4-21 Area A: Note that this fracture surface looks similar to the room temperature fracture but exhibits more intergranular cracking.

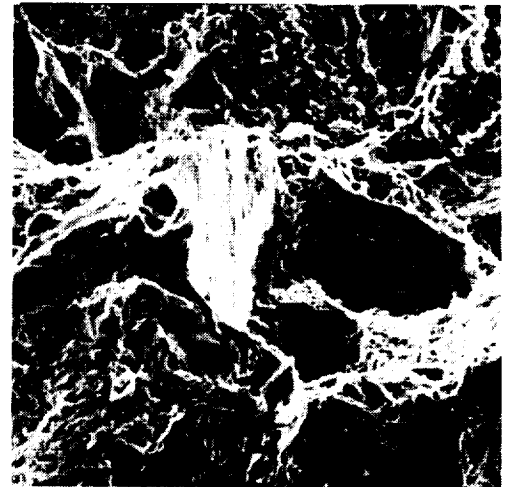
Fig. 4-18 640X  
Region A. Enlarged view of center  
left of Fig. 4-17.

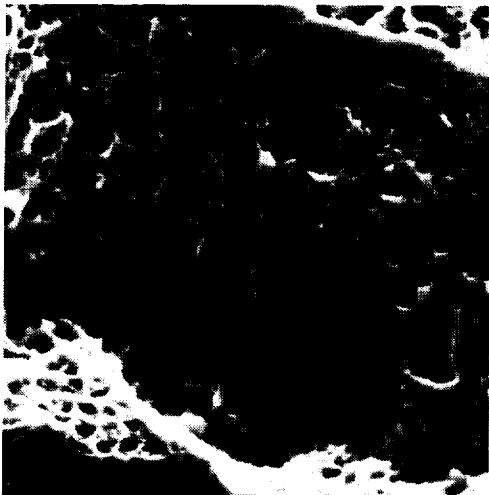
Fig. 4-19 2500X  
Region A. Small dimples on the  
fracture surface of Fig. 4-18.

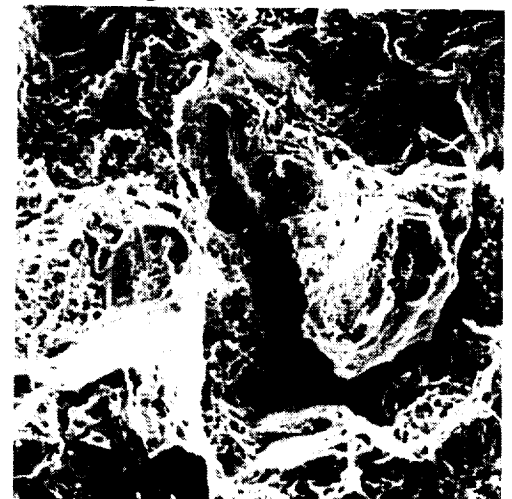
Fig. 4-20 640X  
Region A. Enlarged view of the  
center of Fig. 4-17.

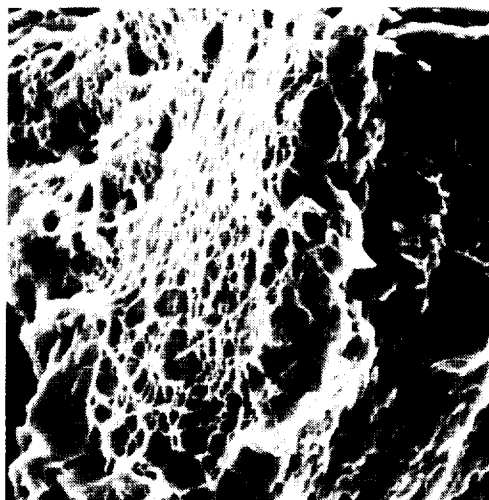
Fig. 4-21 2500X  
Region A. Enlarged view of the  
microdimples in Fig. 4-20.

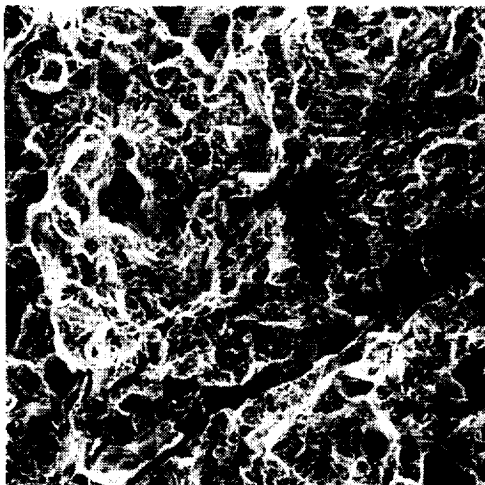
Fig. 4-22 160X  
Region B. An area close to the fracture origin.

Figures 4-22 to 4-24 Area B: These are fractographs in another area near the center of the specimen. Note the mixed mode fracture which is mostly transgranular but includes some intergranular cracking (Fig 4-22, 4-23) and the presence of ductile dimples at high magnification (Fig 4-24).

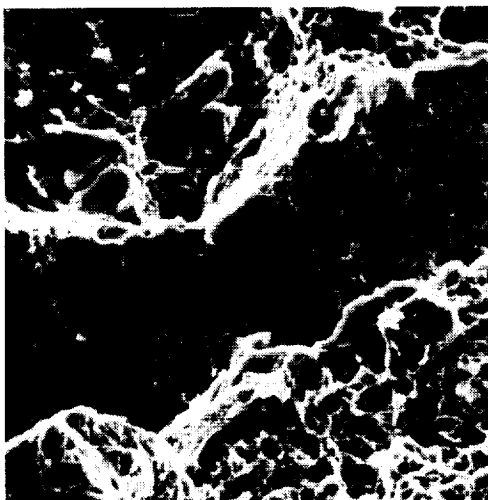
Fig. 4-23 1250X  
Region B. Long band associated with the microstructure.

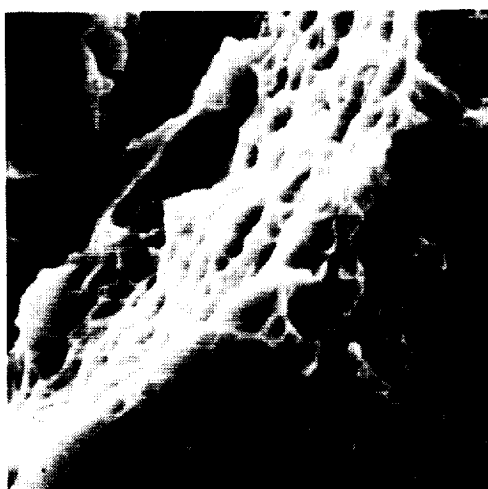
Fig. 4-24 5000X  
Region B. Microdimples.

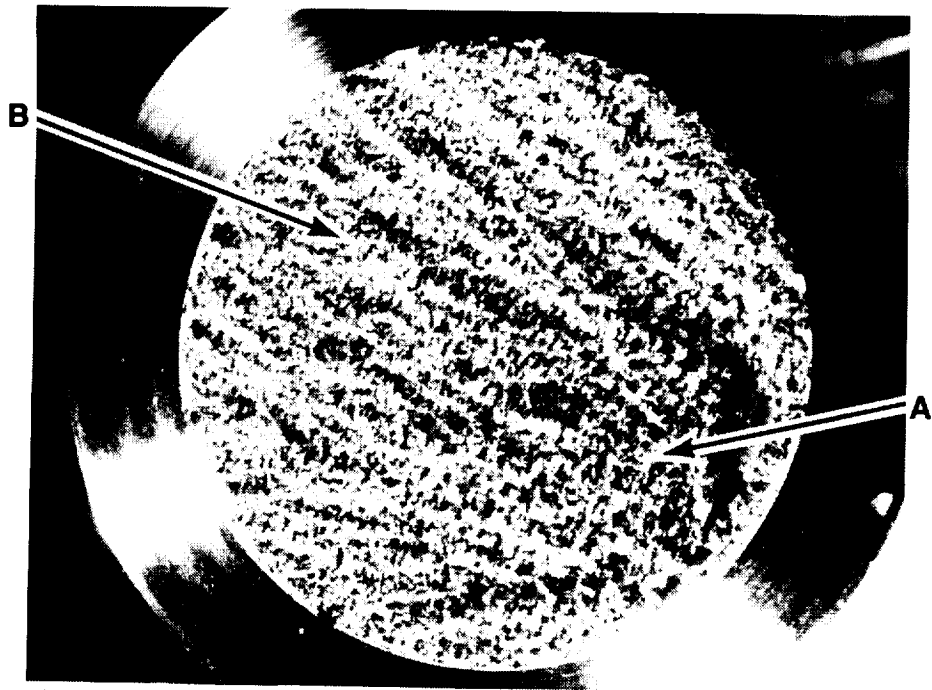
Fig. 4-25  
Optical photomicrograph of the fracture surface.

The fracture is shown in Figure 4-25. This specimen exhibits a smooth surface with small ridges in a slightly radial pattern.

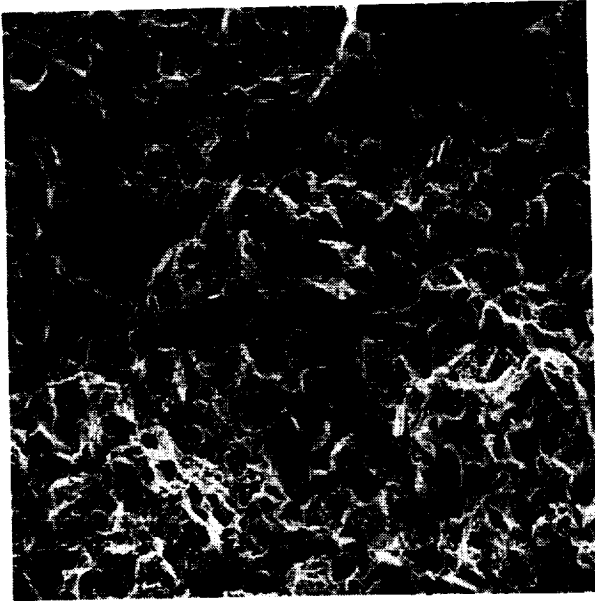
Fig. 4-26 160X  
Region A. An area near the fracture origin.

Figures 4-26 to 4-29 Area A: This area is near the fracture origin. There is some intergranular fracture located among the transgranular ductile dimples.

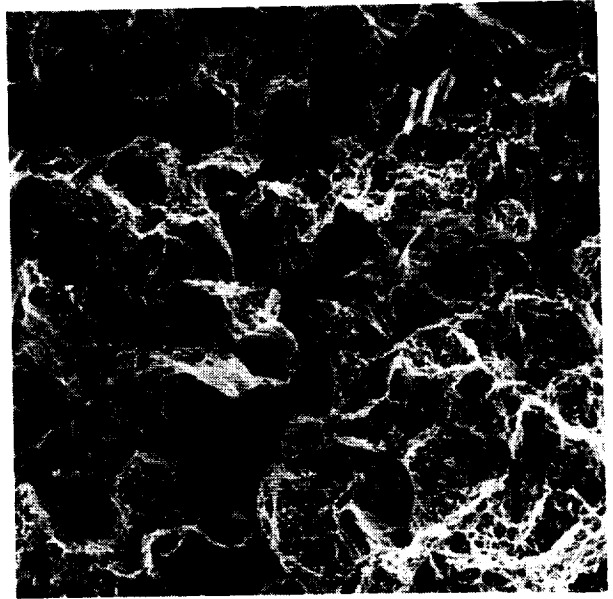
Fig. 4-27 320X  
Region A. Enlarged view of Fig. 4-26.  
Intergranular cracking.

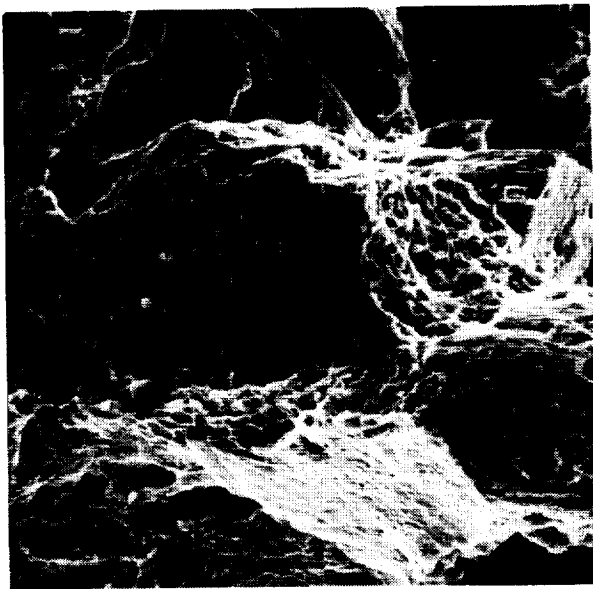
Fig. 4-28 1250X  
Region A. Enlarged view of Fig. 4-27. Dimples.

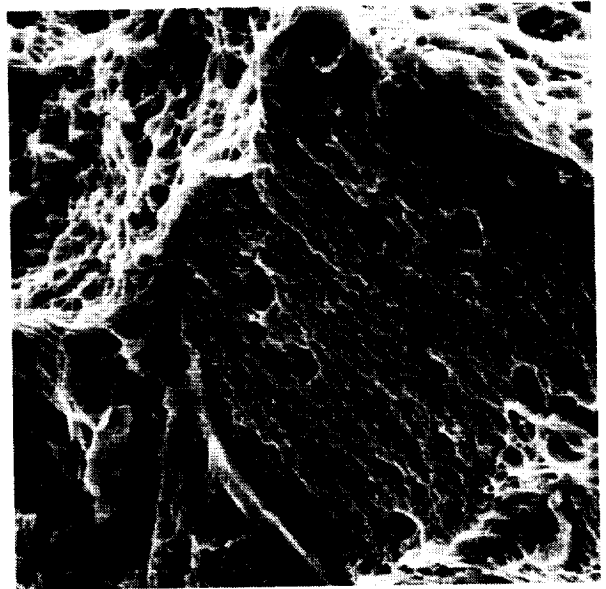
Fig. 4-29 2500X  
Region A. Another enlarged view of Fig. 4-27.  
Dimples on grain facet.

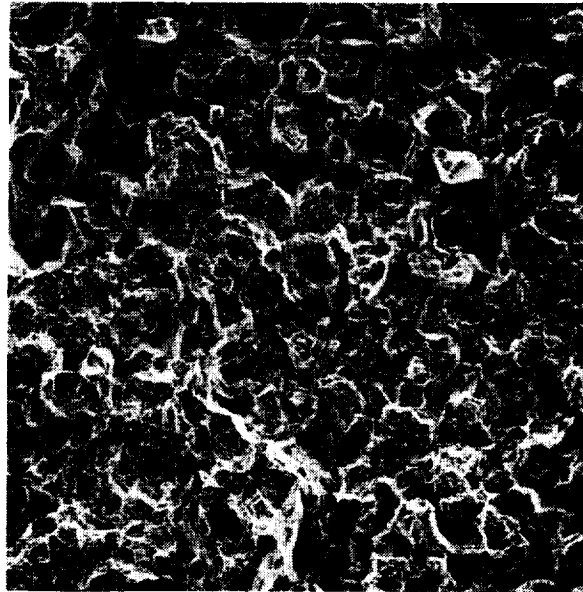
Fig. 4-30 160X  
Region B. Area in the central zone of fracture.

Figures 4-30 to 4-31 Area B: Center of the sample. Mixed mode fracture including intergranular and transgranular fracture is found in this area also.

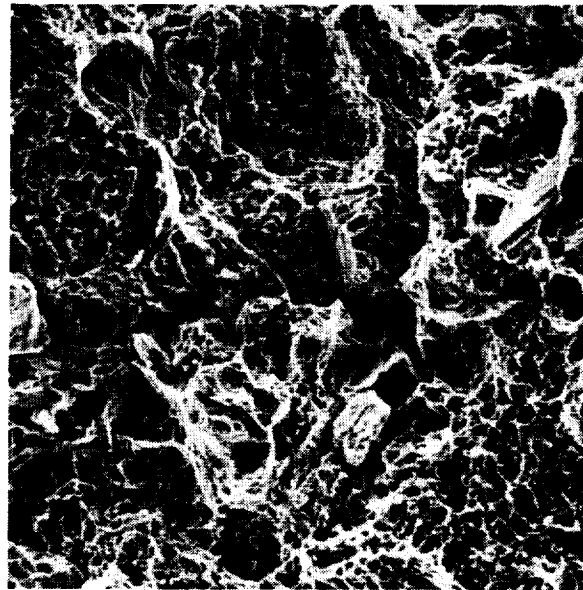
Fig. 4-31 640X  
Region B. Area in the center of Fig. 4-30.

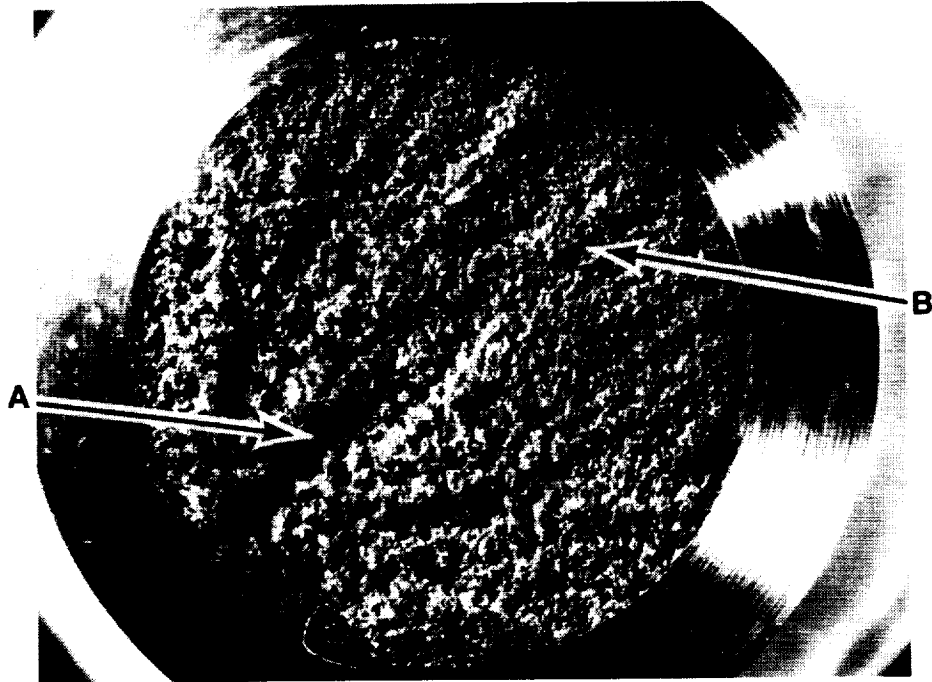
Fig. 4-32

The fracture surface is in Figure 4-32. The cold temperature specimen exhibits a more pronounced radial pattern originating from the fracture origin and a slightly coarser fracture surface.

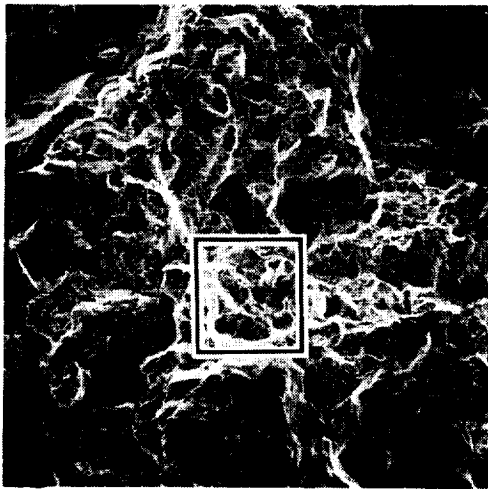
Fig. 4-33 160X  
Region A. An area near the fracture origin.

Figure 4-33 to 4-35 Area A: This area is near the fracture origin. The surface contains intergranular and secondary cracking. The surface reflects the grain structure as more intergranular and secondary cracking has taken place. Note that small ductile dimples are still present throughout the sample (Fig 4-35).

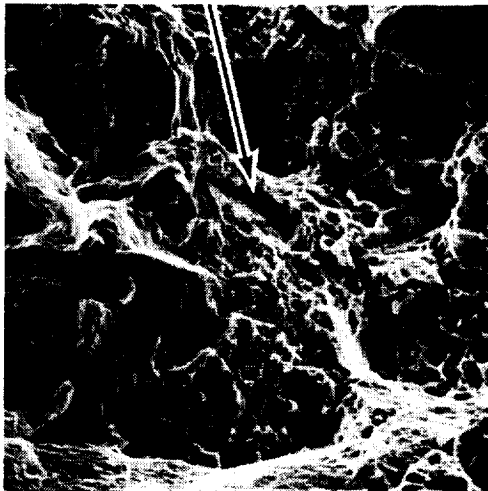
Fig. 4-34 1250X  
Region A. Enlarged view of the center of Fig. 4-33. Arrowhead points to secondary crack.

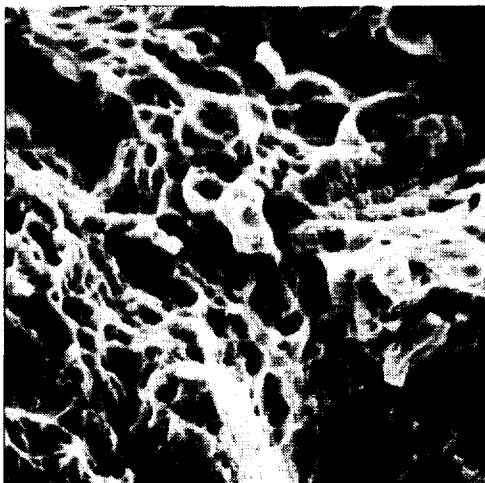
Fig. 4-35 2500X  
Region A. Enlarged view of Fig. 4-34. Microdimples.

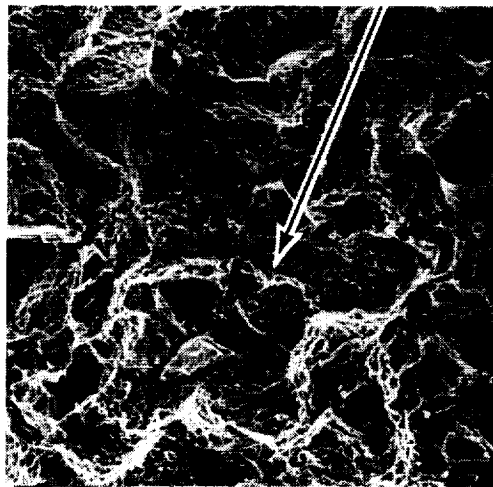
Fig. 4-37 640X  
Region B. An area to the right of the large crack in Fig. 4-36. Arrowhead points to secondary cracking.

Figure 4-36 to 4-38 Area B: A location near the center of the sample that contains a large secondary crack and several smaller secondary cracks (Fig 4-37, 4-38).

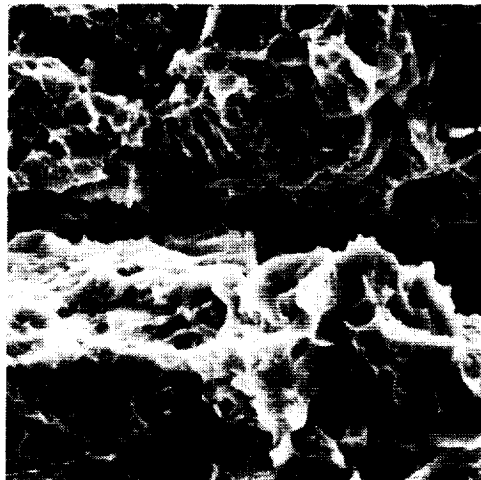
Fig. 4-38 2500X  
Region B. Enlarged view of the secondary crack in Fig. 4-37.

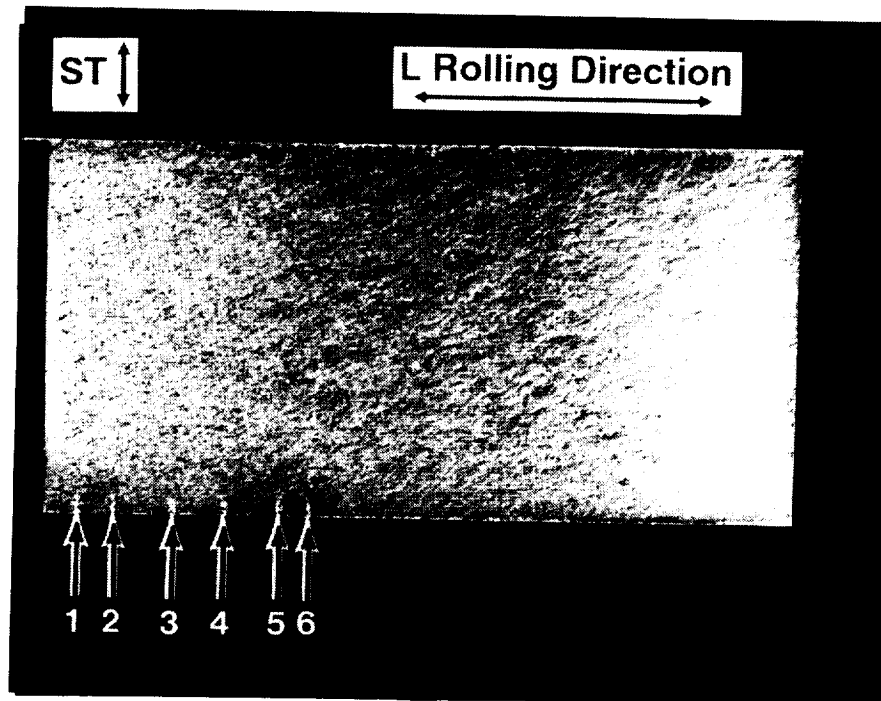
The different regions of crack growth rates are not visible in the optical photograph in Figure 4-39 but a scribe mark is identified as the approximate beginning of each region. Region 1 and Region 6 are the precrack and final fast fracture regions, respectively, and were not documented. Regions 2 through 5 represent four different loading conditions and their fracture surfaces were documented with SEM fractographs.

Fig. 4-39  
Optical photomicrograph of the fatigue fracture surface.

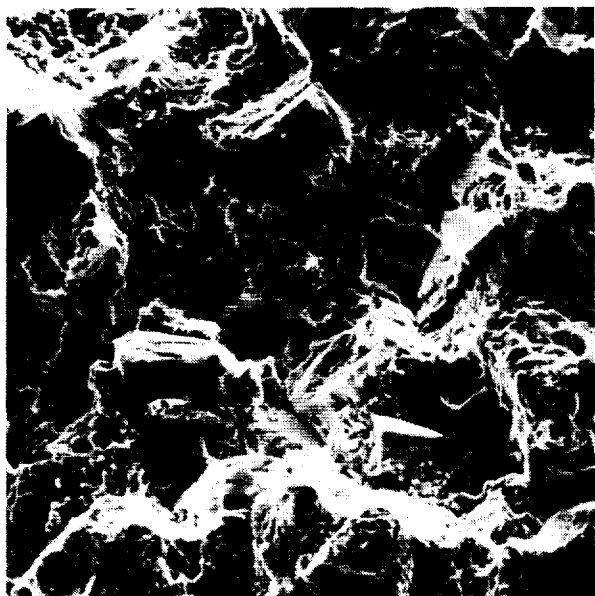
Fig. 4-40  
Region 2. 640X

Figures 4-40 to 4-43 Region 2: The striations are very difficult to find even at 10,000X at this load parameter.

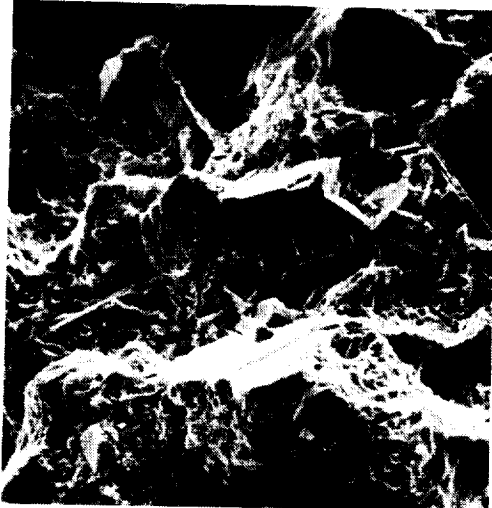
Fig. 4-43  
Region 2. 10000X

Figures 4-44 to 4-46 Region 3: The striations are not apparent at these load conditions either. The parallel markings are possibly slip planes.

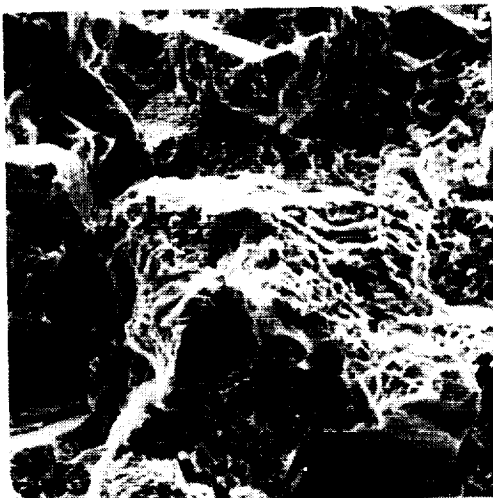
Fig. 4-46  
Region 3. 2500X

Figures 4-47 to 4-49 Region 4: Striations are not apparent here either.

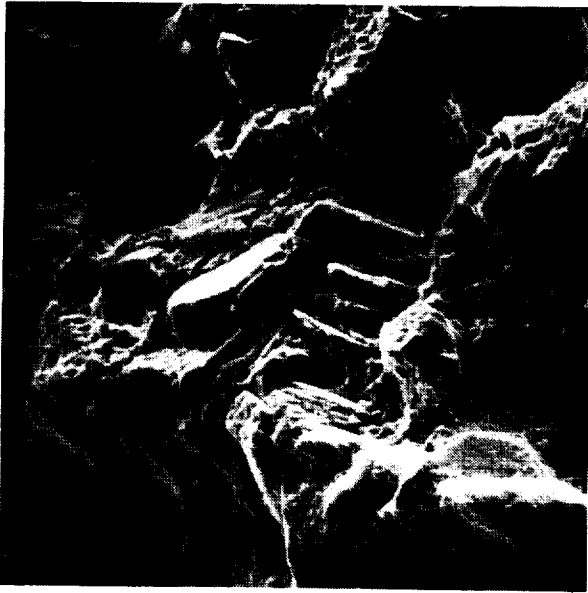
Fig. 4-49  
Region 4. 5000X

Figures 4-50 to 4-53 Region 5: Striations are evident at 5,000X and 10,000X.

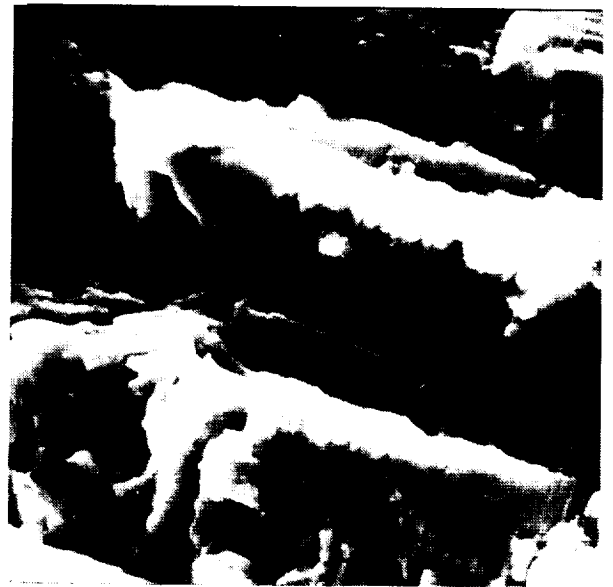
Fig. 4-50  
Region 4. 640X

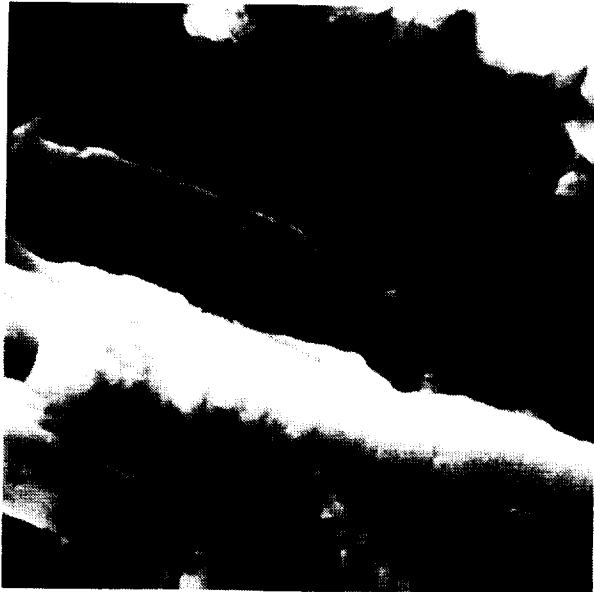
Fig. 4-51  
Region 4. Fatigue striations. 5000X

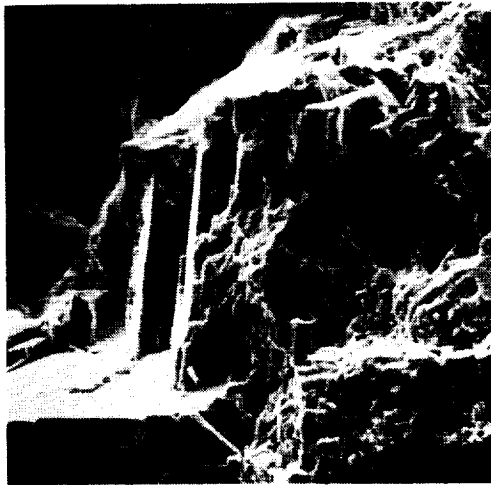
Fig. 4-53  
Region 4. Fatigue striations. 20000X

Figures 4-54 to 4-56 Region 5: Another area in Region 5. Striations are not evident in this area.

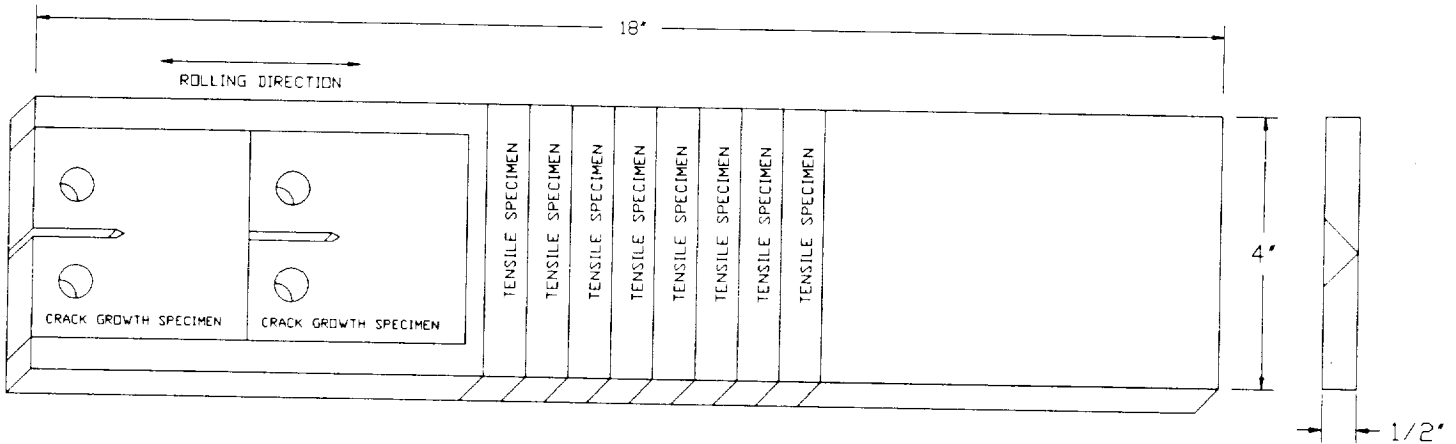
Figure 5-a. Diagram of pattern used to cut welded test specimens

Two pieces of 6061 aluminum were welded together with 4043 filler metal as shown in Figure 5-a.

**Dimensions:** 0.5" Tk X 4" W X 16" L. The specimen did not weld properly and thus there is an area where there is lack of penetration. The lack of penetration is evident in the microstructure as well as in the fracture surfaces.
